Alford Arm Creek EcoSummary

The Alford Arm tributary is a moderately altered, nitrogen-limited stream located in the northern part of Leon County. The tributary flows from Lake McBride in the Bradfordville area and receives runoff from the heavily developed Killearn Estates and Killearn Acres neighborhoods. Many of the waterbodies within these neighborhoods are former agricultural ponds, most notably the Velda Dairy impoundments that are now seen as residential amenities.

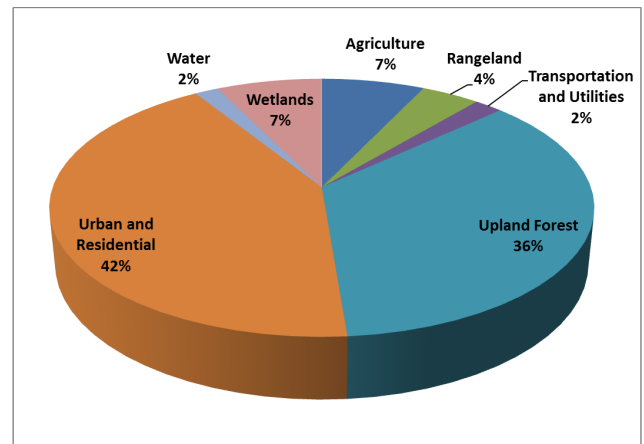
Figure 1. Alford Arm Creek watershed land use.

Approximately 55% of land use in the 26,913-acre watershed is agriculture, rangeland, transportation, utilities, urban and residential (as shown in **Figure 1**). Increases in stormwater runoff and waterbody nutrient loads can often be attributed to these types of land uses.
