Lake Carr EcoSummary

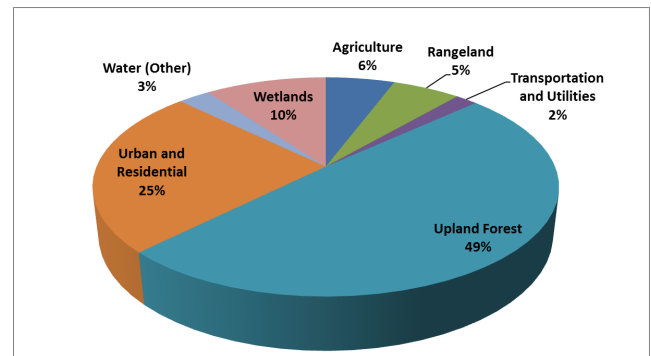
As shown in **Figure 1**, 38% of land uses in the 5,931-acre Lake Carr watershed are agriculture, rangeland, transportation, utilities, urban and residential. These types of land uses are often attributed to increases in stormwater runoff and higher nutrient loads. The lake receives direct runoff from the surrounding agricultural property as well as flow from the residential areas east of Meridian Road (Summerbrooke and Ox Bottom Manor). Waterbodies in the residential areas are modified farm ponds serving as stormwater facilities dedicated to the respective homeowner's associations for maintenance. The Summerbrooke Golf Club (157 acres) also lies in this watershed.

Figure 1. Lake Carr watershed land use.

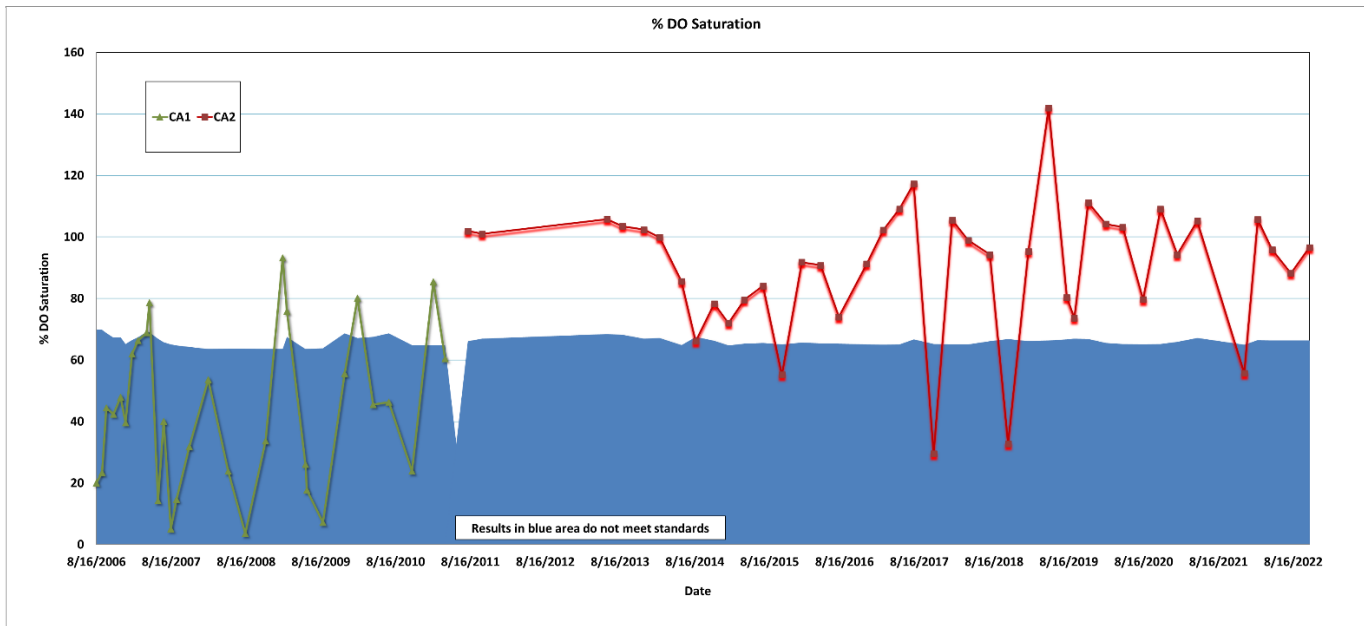
As **Figure 2** shows, station CA1 dissolved oxygen (DO) percent saturation values did not meet Class III water quality criteria while station CA2 failed to meet the criteria four times during the sampling period. This was not unexpected, since the CA1 station is a shallow station normally covered with vegetation, which prevents rapid water exchange with the larger area of the lake. Plant respiration (samples were often taken in the morning hours) also contributed to the low DO saturation values. While there is a substantial community of submerged vegetation at the CA2 station, emergent vege-

tation is relatively uncommon at this site, so conditions are more optimal for rapid water exchange with the remainder of the lake. Staff believes that this is a natural condition for both locations.

Figure 2. Dissolved Oxygen Percent Saturation results for Lake Carr.

Based on ongoing sampling, Lake Carr met the NNC for the East Panhandle Region. Staff considers the DO results at Stations CA1 and CA2 a natural condition. The LVI score for Lake Carr was 62, placing the lake's vegetative community in the Healthy category.
